Streambank Erosion Control on the Winooski River, Vermont

FRANK C. EDMINSTER, Regional Biologist

UNITED STATES DEPARTMENT OF AGRICULTURE

OCTOBER 1949

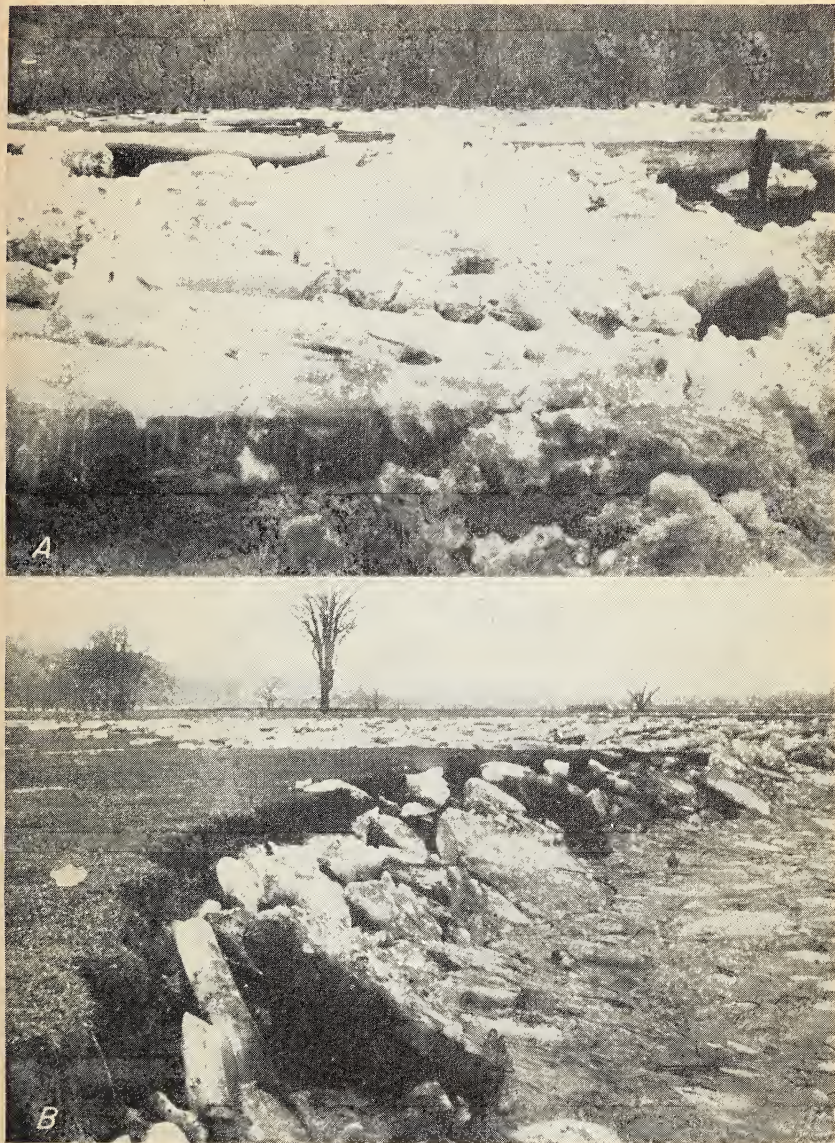
Ice floes have contributed materially to bank erosion by destroying protective vegetation, gouging out the earth and creating turbulence in the stream. Large trees on the bank have also created turbulence, which has resulted in scouring. The trees eventually fell into the river and the tree tops, by throwing the current in a new direction, helped to increase the damage. In several cases, the river in shortening its course between bends has cut new channels through the bottom land. The severest test of control measures was that presented by the impact of high-velocity flood flows and heavy ice floes (fig. 1).

FIGURE 1.—Ice subjects all erosion-control measures to a severe test. *A*, Ice deposited on pasture by floodwater; *B*, erosion of bank caused by ice action.

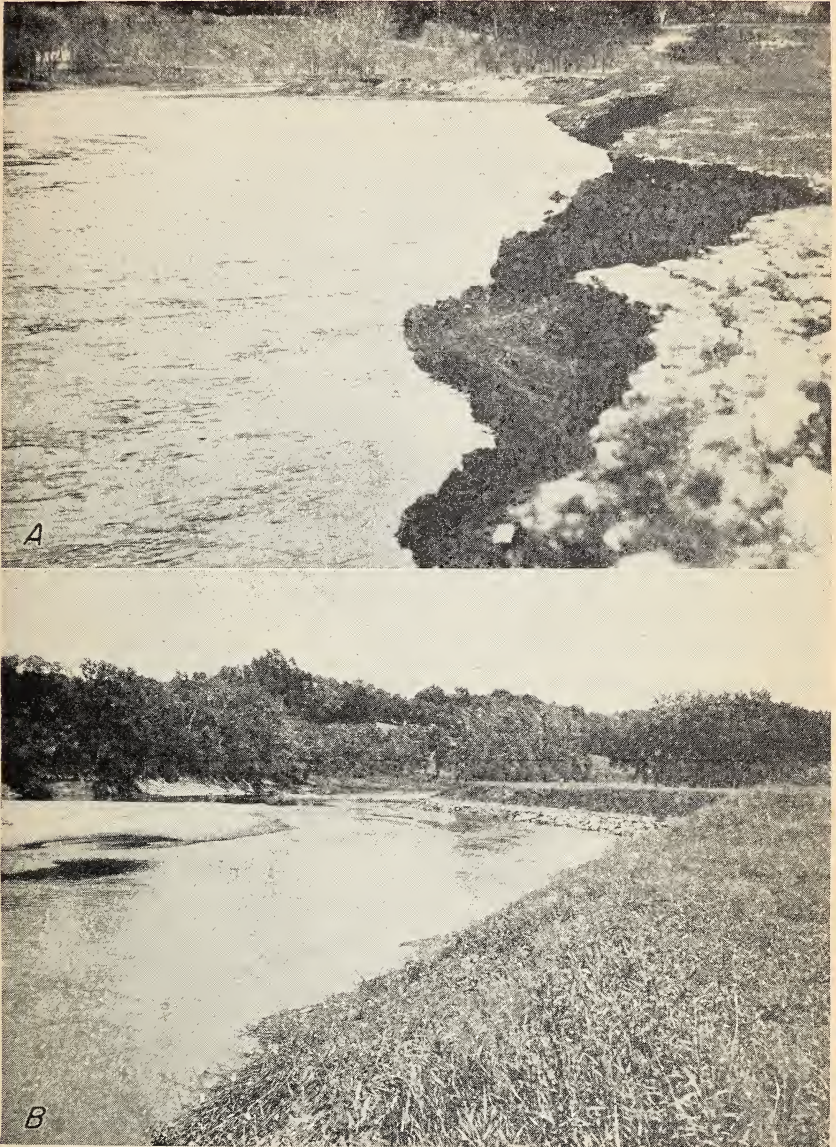
FIGURE 2.—A section of riverbank where erosion was successfully controlled by a combination of structural and vegetational measures. *A*, Bank erosion caused by 1936 flood, before treatment; *B*, same bank after sloping, with lower portion riprapped with stone, upper portion planted and brush-matted.

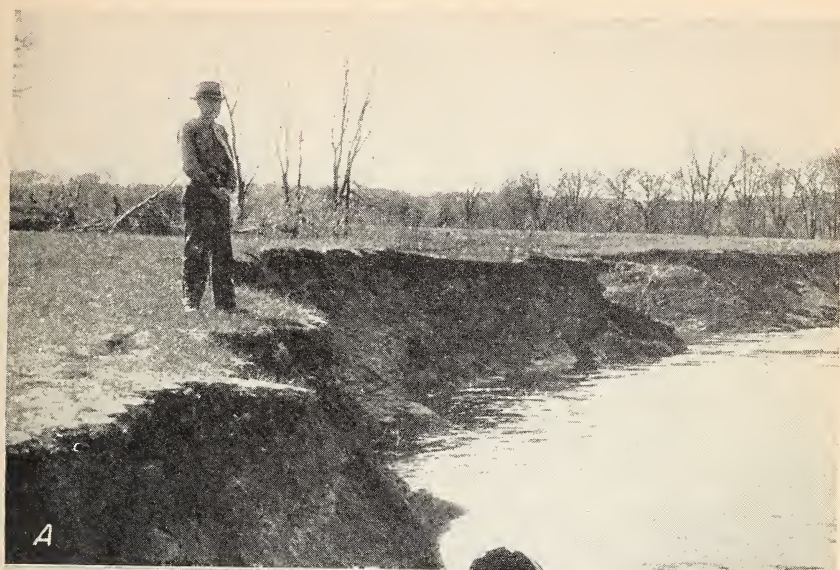
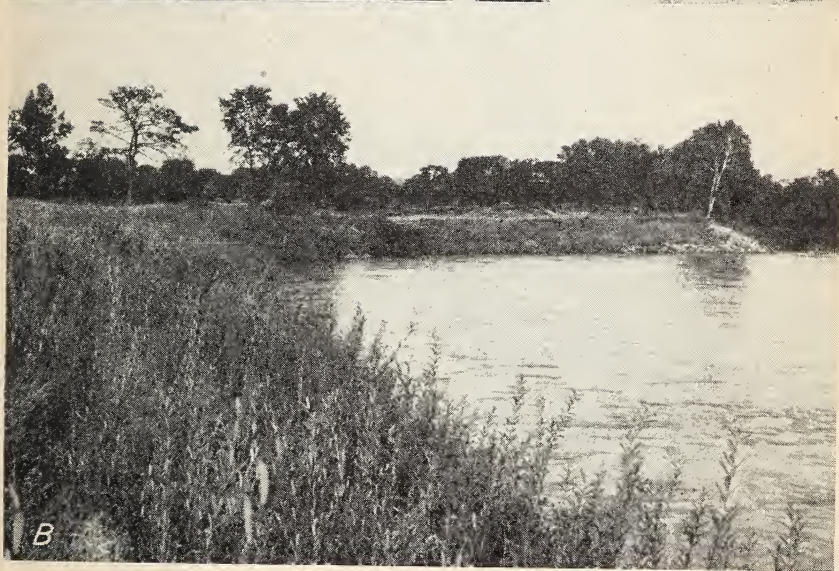
FIGURE 3.—Severely eroded riverbank. *A*, Prior to treatment in 1937; *B*, same bank in 1938 after it was sloped, brush-matted, and planted with purple-osier willows, and toe of slope riprapped. Willows are in second growing season. These photographs should be compared with the three following ones illustrating the conditions in later years.

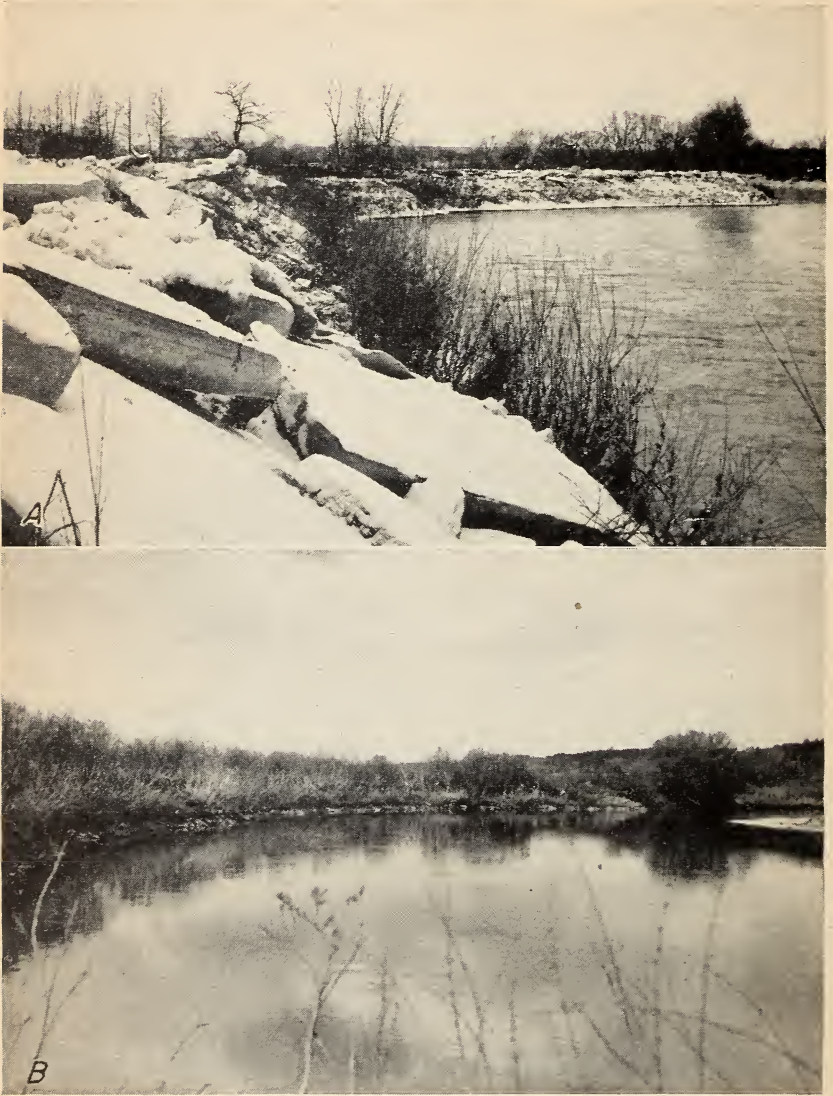
FIGURE 4.—Purple-osier willows are well adapted for bank-erosion control. *A*, Heavy layer of ice cakes deposited by spring flood on the bank shown in figure 3; *B*, same bank after ice receded. The resilient willows were scarred but remained intact and the bank is not seriously damaged.

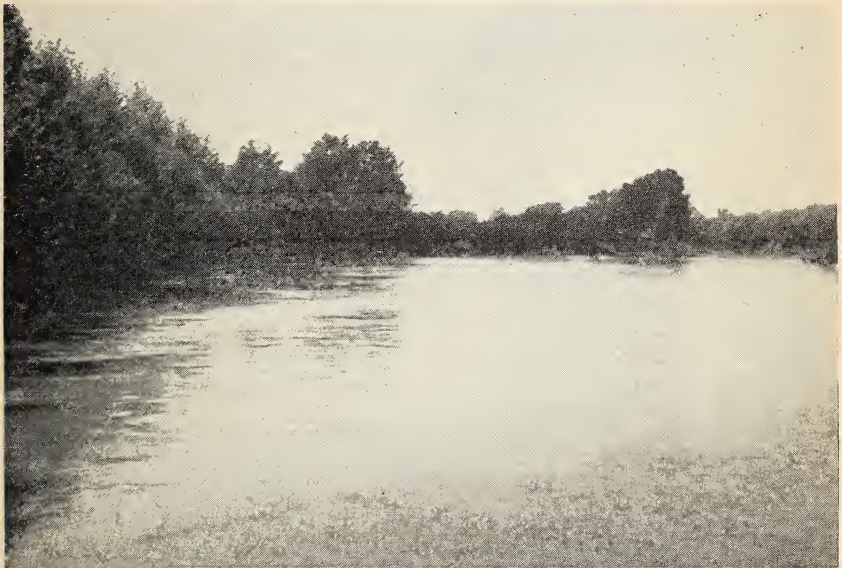
FIGURE 5.—By 1945, a well-vegetated bank had replaced the raw eroding bank shown in figure 3, A.

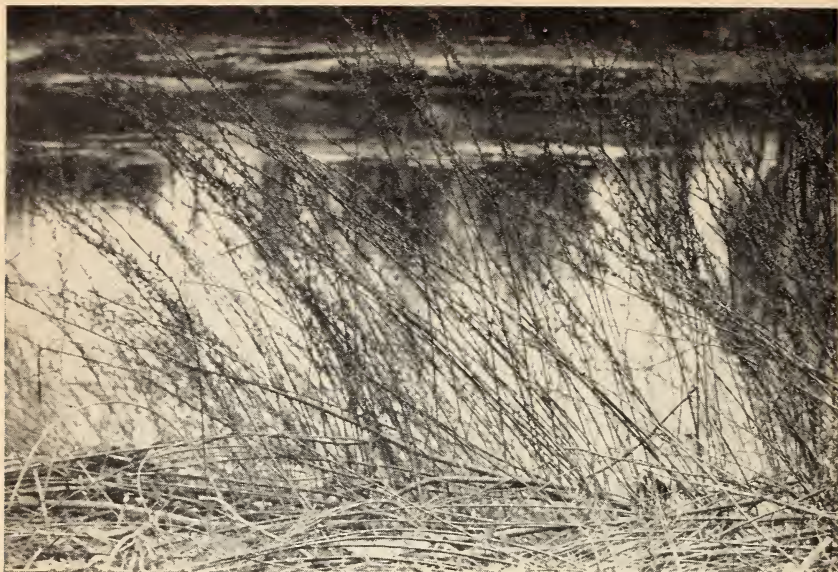
FIGURE 6.—Purple-osier willow is the best willow for streambank use in the Northeastern States. Its resilient stems assume their original erect form after having been flattened by ice and water. New plants grow from the silted-over tips.

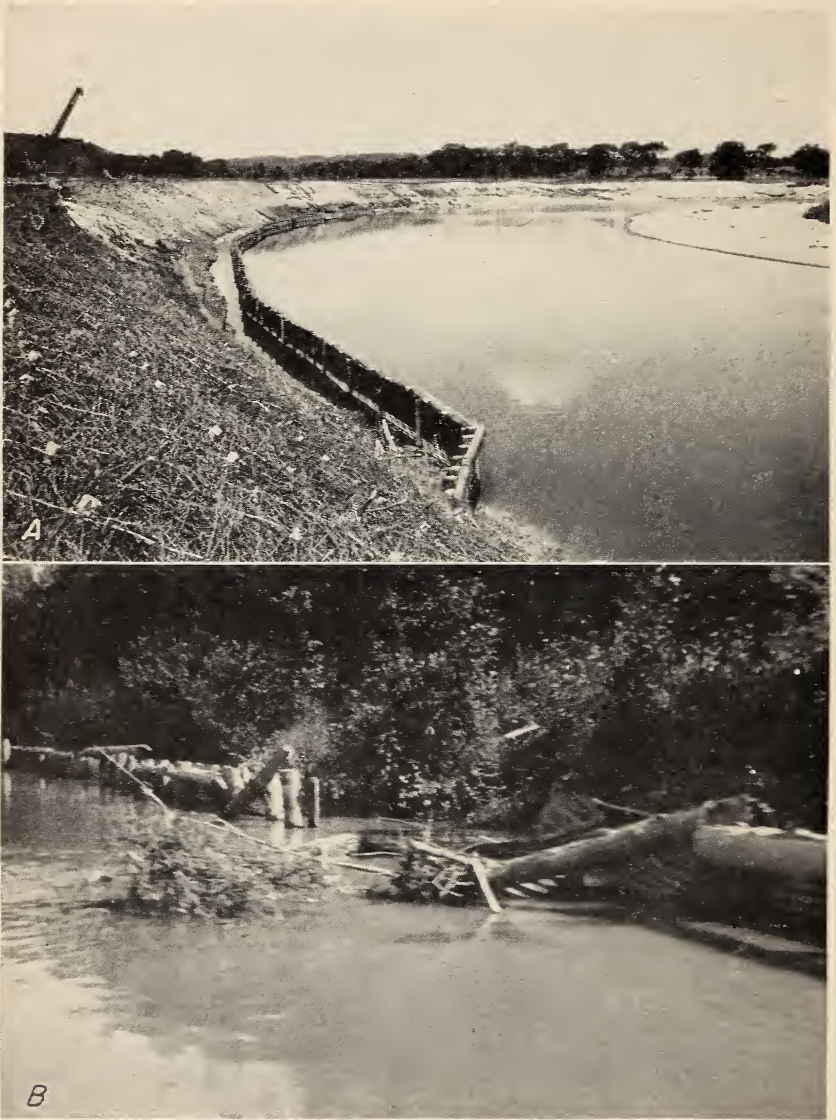
FIGURE 7.—Revetment of log piling and corrugated metal. *A*, Retaining wall, with bank sloping, planting, and brush matting in various stages of completion, 1938; *B*, section of revetment destroyed by the impact of floods as photographed in 1945.

This type of structure was found to be unsatisfactory. The bank continued to slip, and the piles and metal deflector failed in several places owing to ice action and bank pressure.

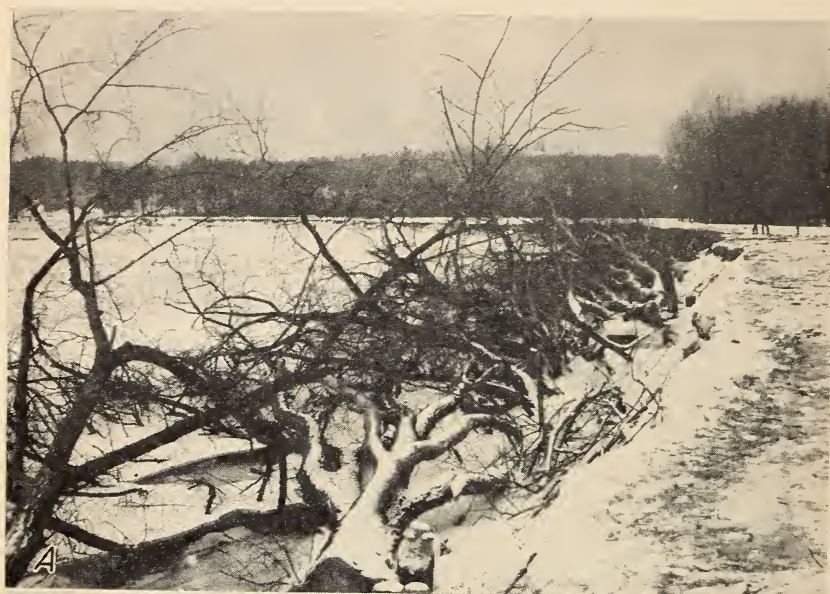
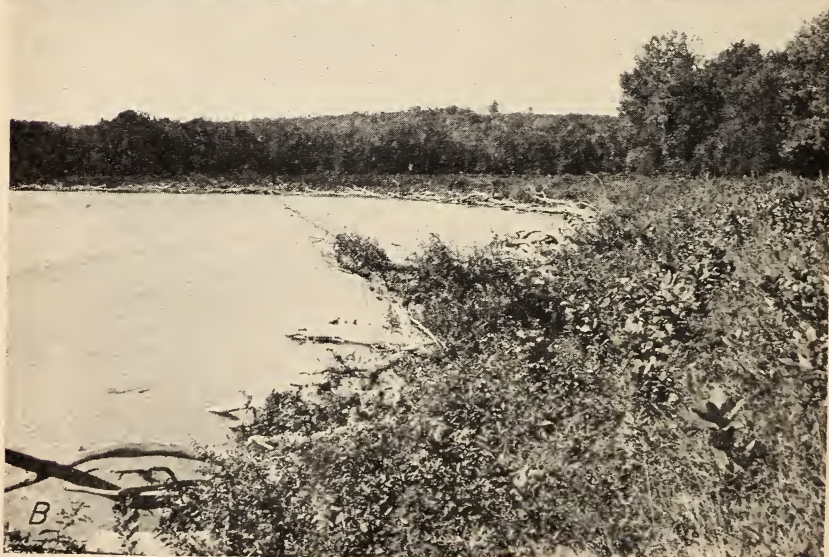
FIGURE 8.—Whole-tree deflector: *A*, Whole trees placed at toe of bank and cabled to log piles, 1938; *B*, same bank in 1941, after planting.

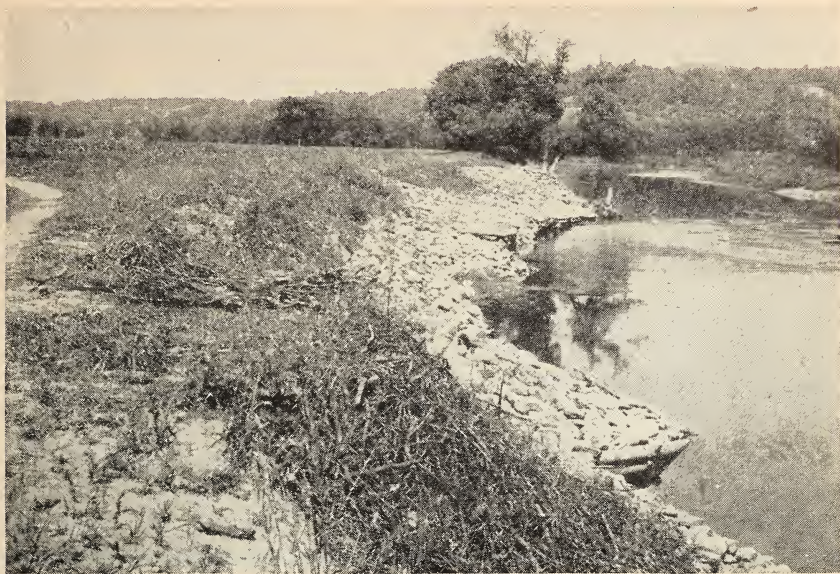
Instead of causing deposition, however, these cribs caused an overfall and turbulence, with consequent destructive scouring on the down-

FIGURE 9.—Streambank protected by stone-filled log-crib jetties (wing cribs) supplemented by stone riprap.

stream side. This type of structure is more expensive than simple stone riprap.

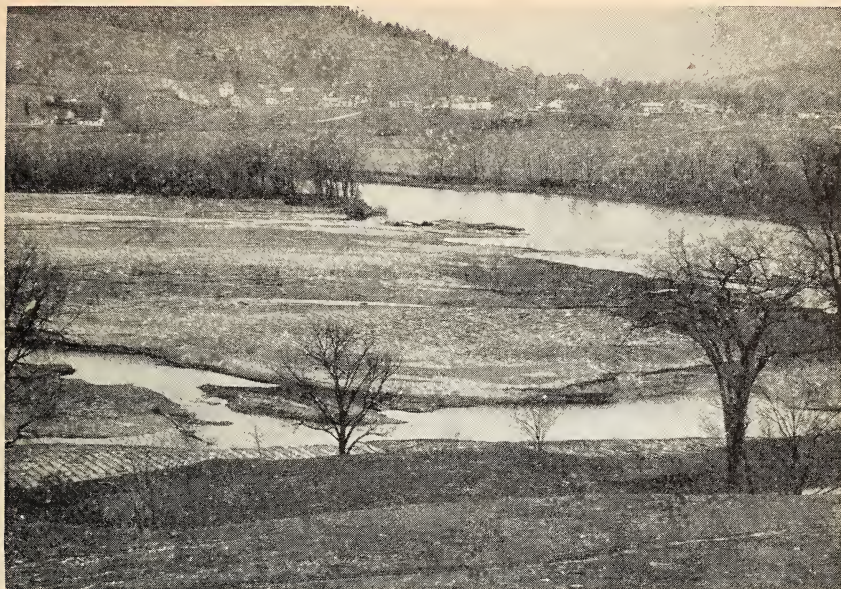
FIGURE 11.—New channel (foreground) cut through farm land by Winooski River during 1936 flood.

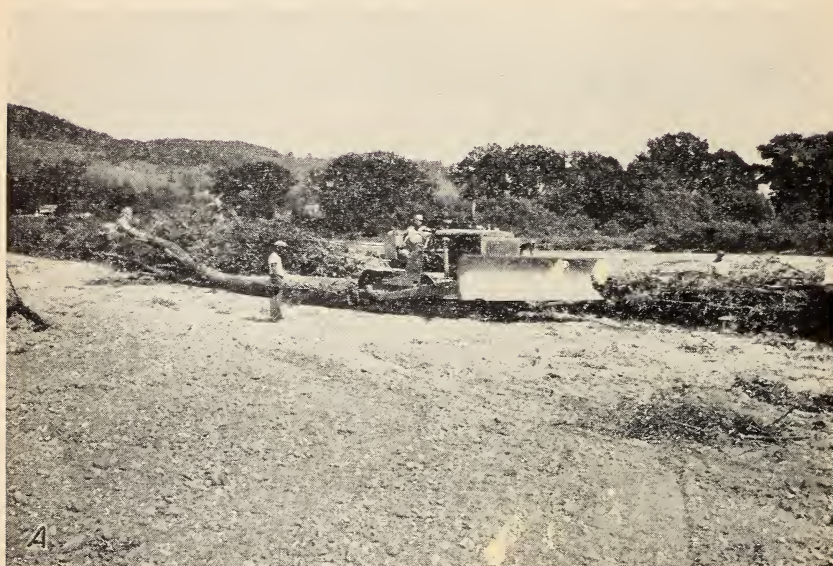
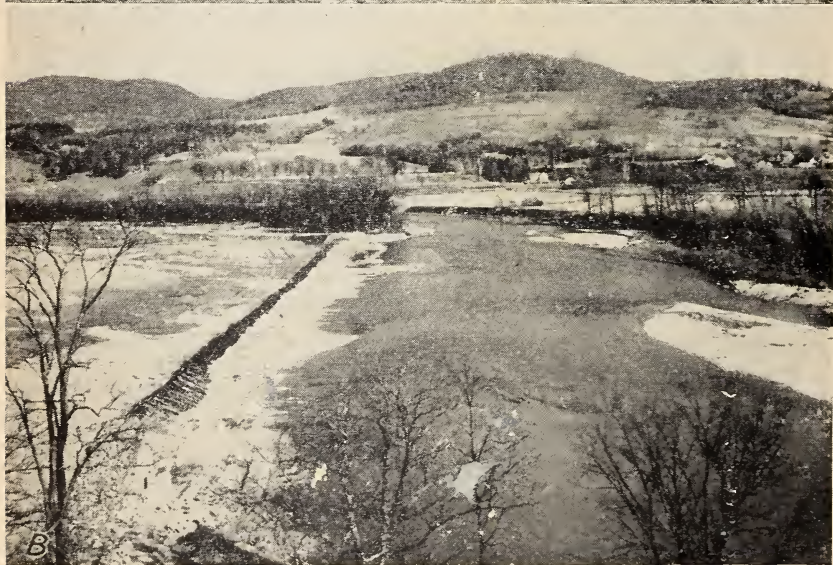
FIGURE 12.—Tree barricade across main chute. *A*, Trees are pushed into place by bulldozer and securely cabled together; *B*, completed structure showing rock-filled log crib at end (lower left).

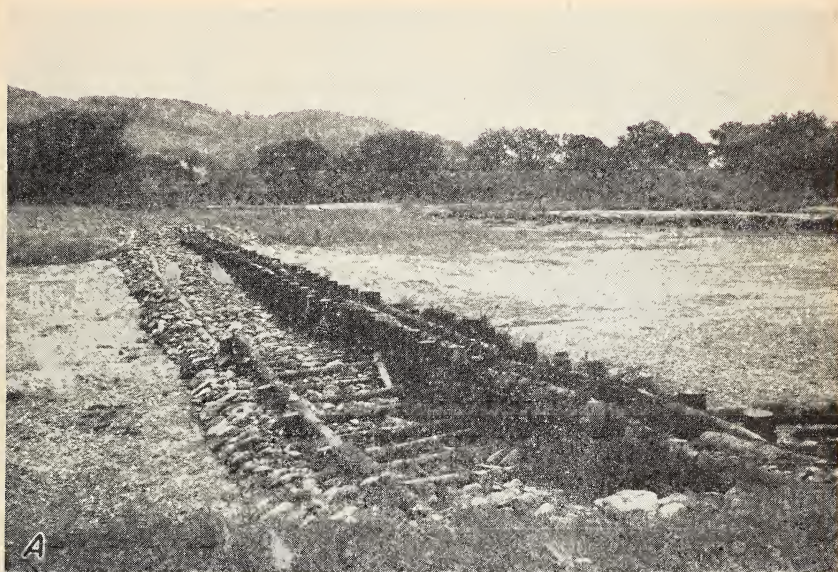
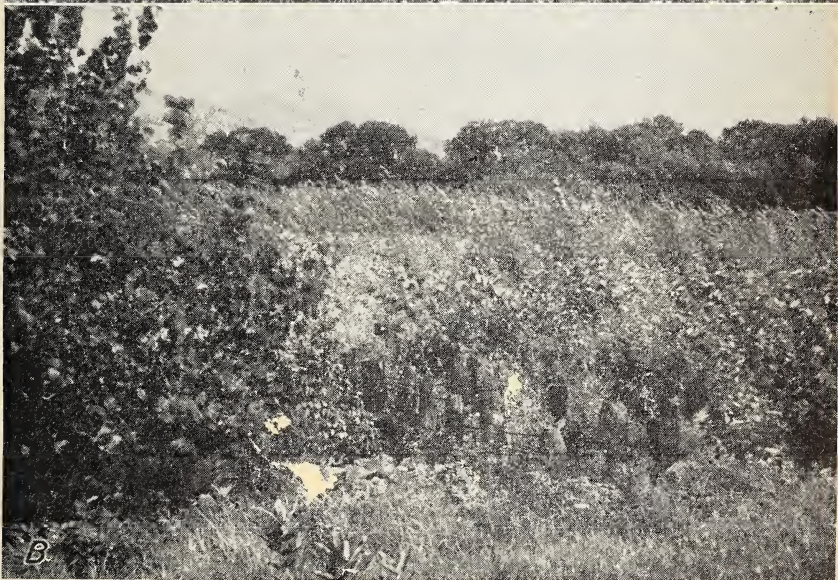
FIGURE 13.—Log-pile check dam constructed in new channel just below main barricade: *A*, Just after construction in 1938 showing stone apron; *B*, 4 years later showing growth of buffer planting.

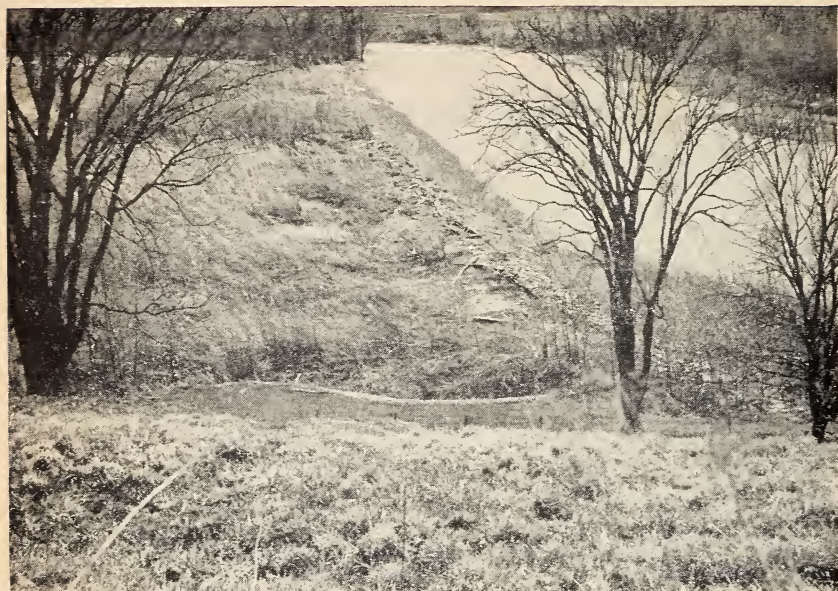
FIGURE 14.—Barricade and buffer planting showing temporary damage to trees caused by spring flood of May 13, 1946.

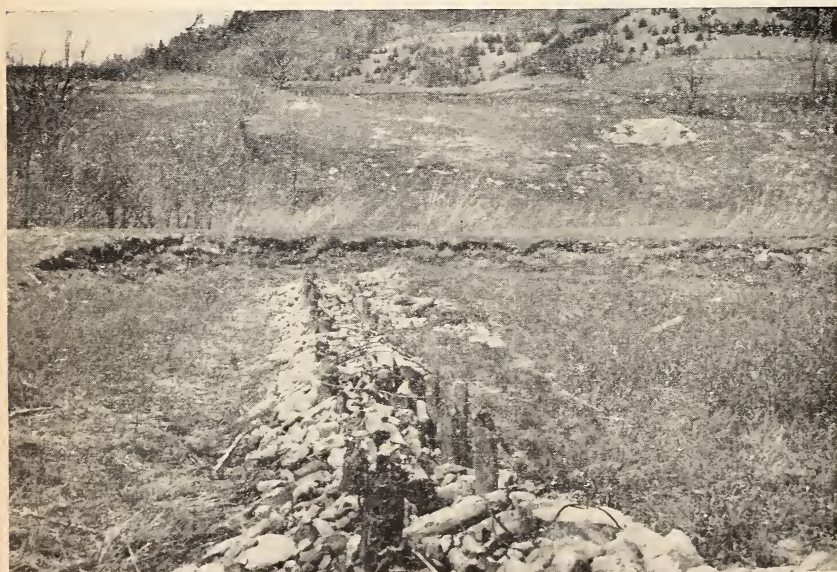
It is essential that a dense sod of perennial grasses be maintained at the ends of the check dams in order to prevent end cutting. When land close to the end of the structure is plowed and cultivated, the disturbed soil is highly vulnerable to erosion. Floodwaters easily open a by-pass channel in such places (fig. 15).

FIGURE 15.—New channel cut through plowed soil at farther end of check dam, 1946.
